Focus Area 4: Seismic Risk Management Applications in Infrastructure Management

Overview of Great East Japan Earthquake in Tohoku Areas

Keisuke Inoue

Deputy Director, Planning Department, Tohoku Bureau, Ministry of Land, Infrastructure, Transport and Tourism (MLIT)

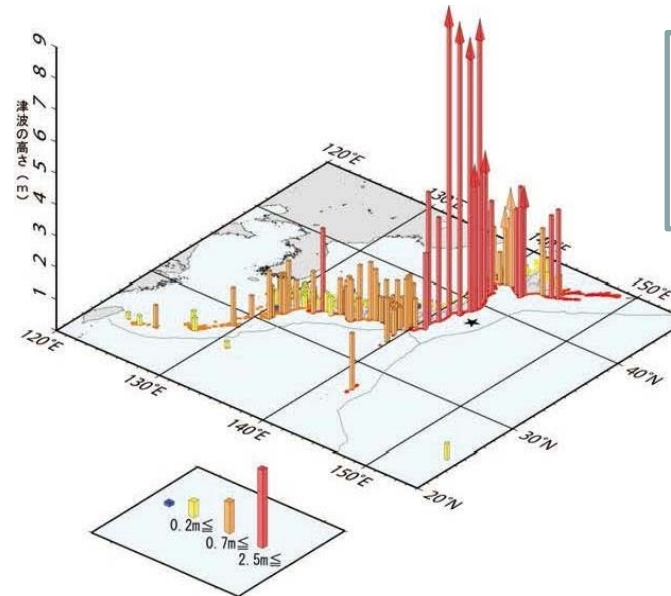
Tsunami heights observed by Japan Meteorological Agency (JMA) observation facilities

- **Amplitude: 8 - 10m** along the coastal area of eastern Japan
- **Run-up height: over 30m** found in some places

Arrows mean higher tsunami were expected but the earlier tsunamis damaged observation facilities and prevented their actual data acquisition.

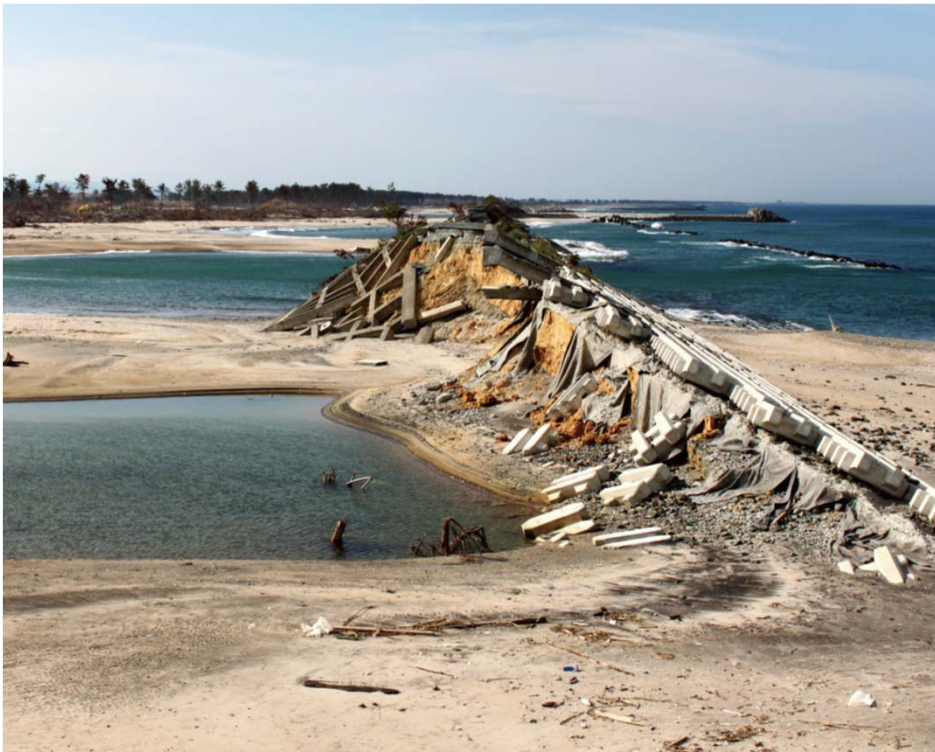
▲ **Seawalls broken by tsunami**
Southern coastline of Sendai Bay
Yamamoto Town, Watari Country, Miyagi Pref.

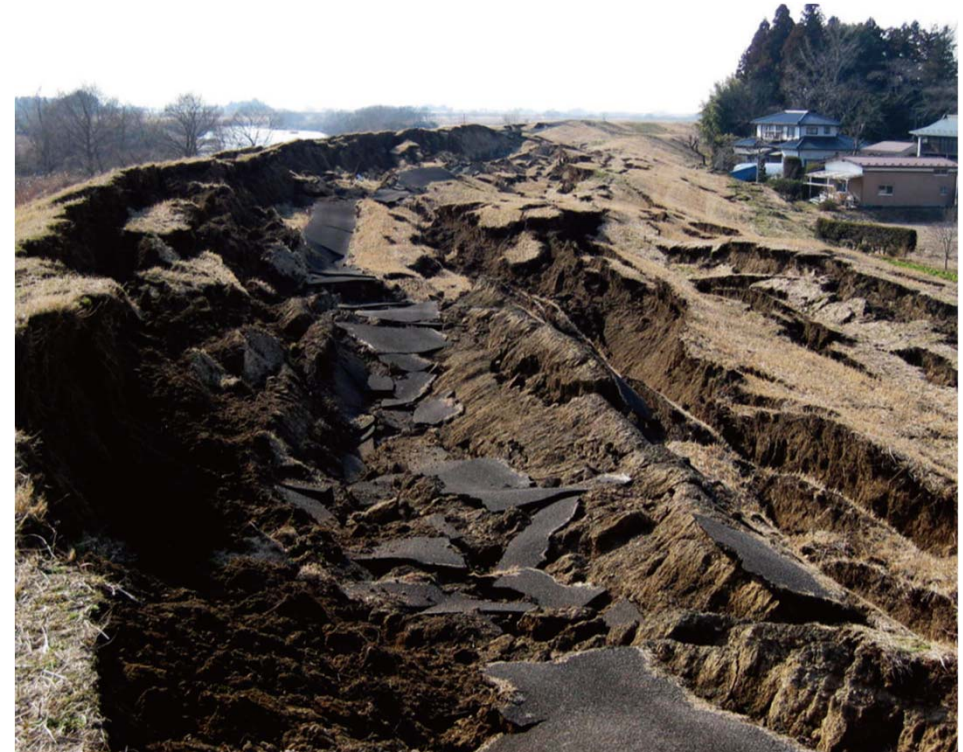
▲ **Massive land sinking under Seawalls**
Left bank of Naruse river,
Shimonakanome, Osaki City, Miyagi Pref.

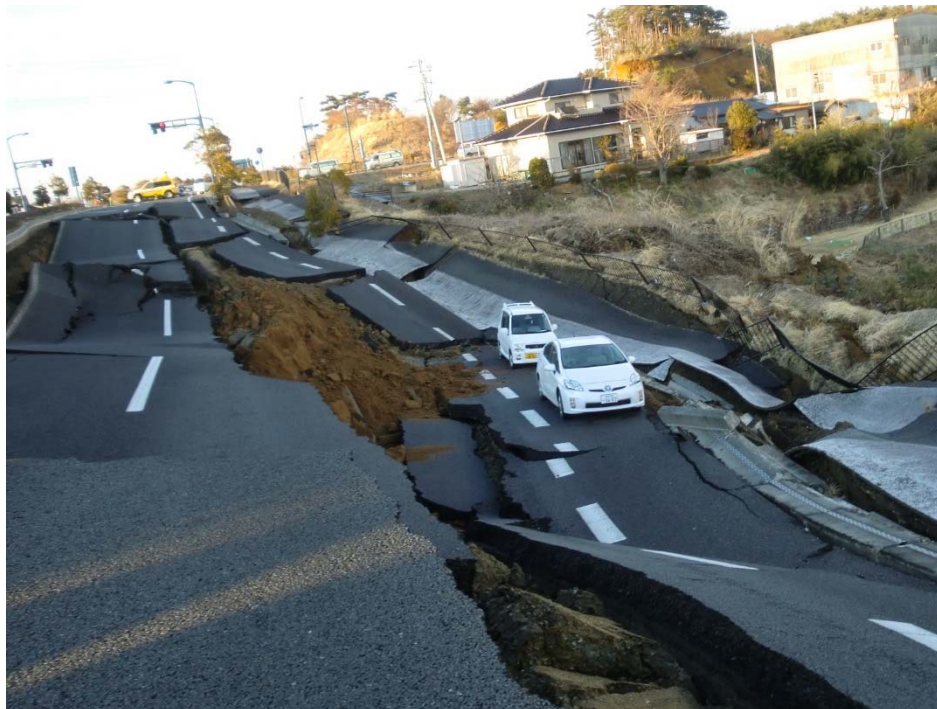
▲Route 6 was heavily damaged.
Hirono Town, Fukushima Pref.

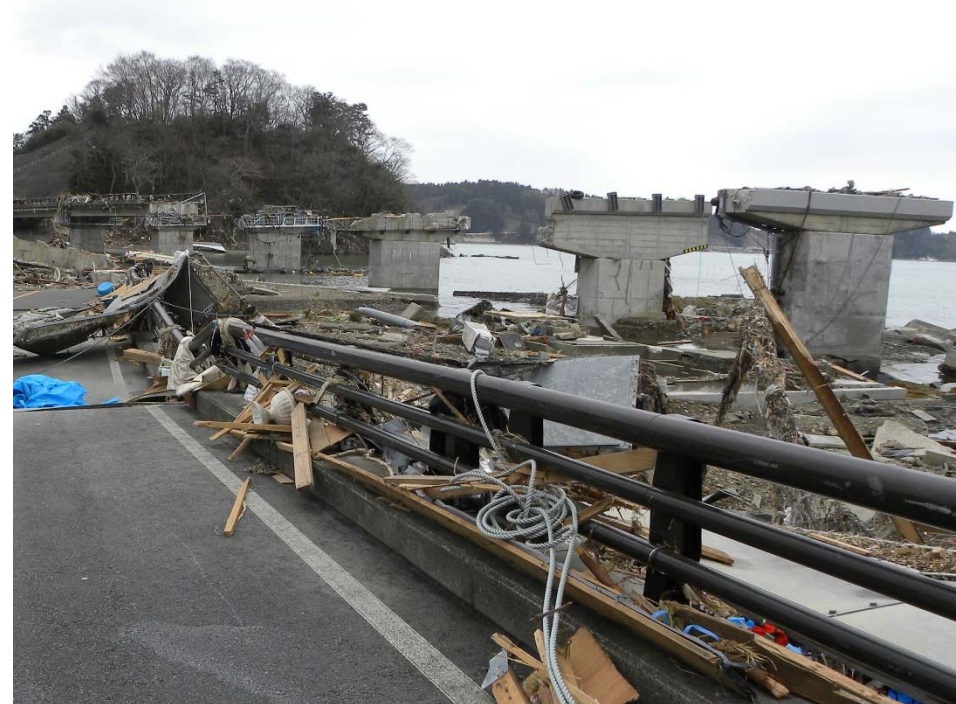
▲Bridge girders on Route 45 were completely swept away.
Minamisanriku Town, Miyagi Pref.

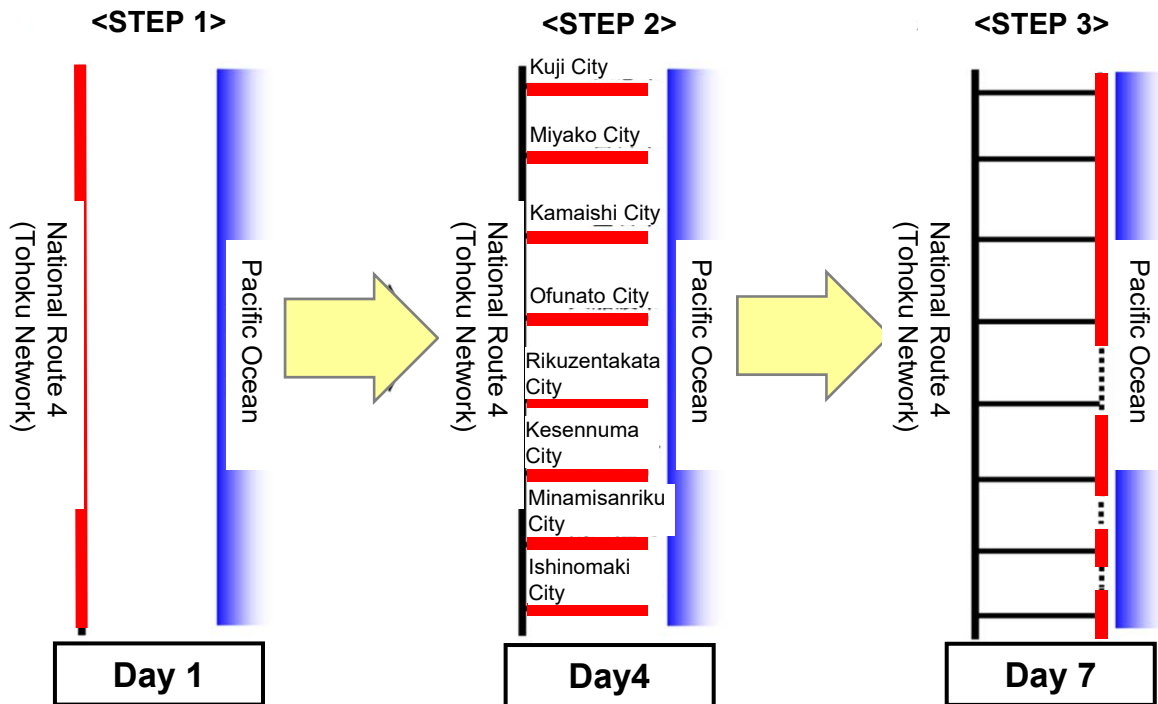
Operation Comb

STEP 1 Extend **North-south inland routes**
from Tohoku Expwy, National Highway 4

STEP 2 Extend **East-west routes and west routes**
from Tohoku Expwy, National Highway 4

March 12 11 of 16 routes open to traffic
March 15 15 of 16 routes open to traffic

STEP 3 **March 18** 97% of Route 45 & 6 open to traffic
(Mission Completed)

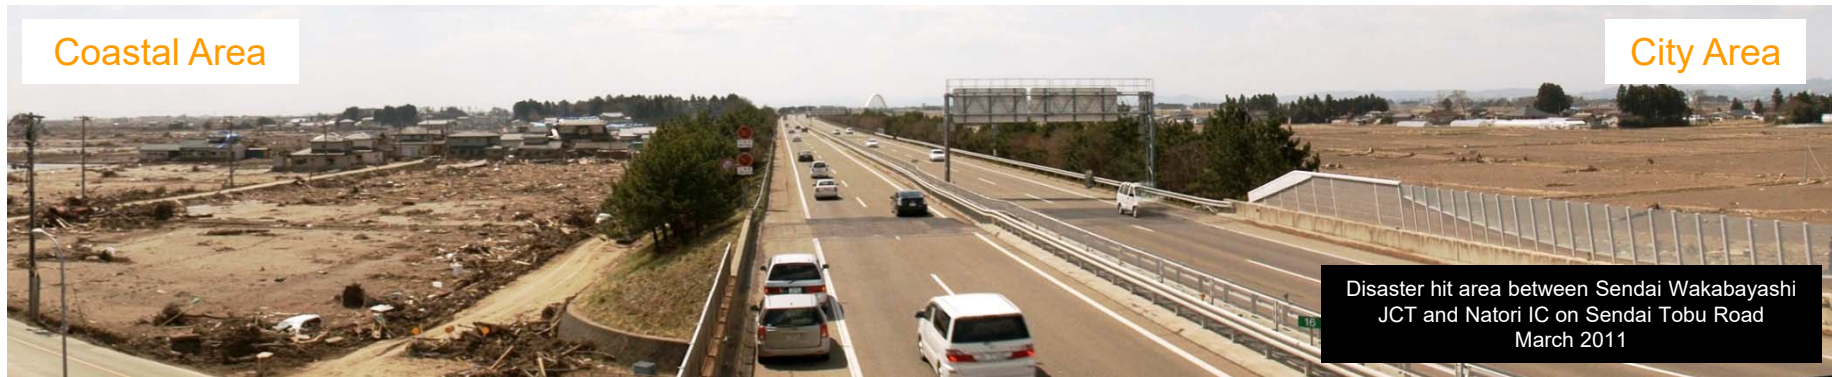
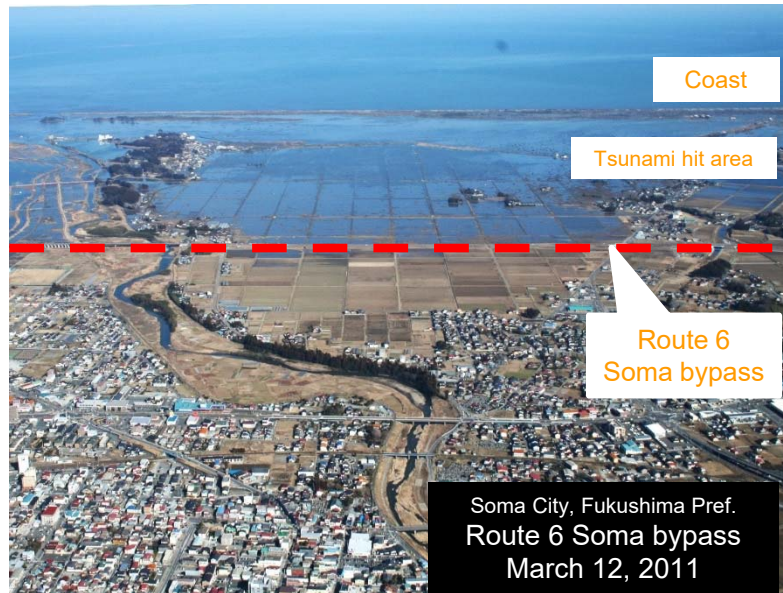
Elevated expressways functioned as levees.

- In the 2011 Tsunami disaster, elevated expressways prevented the inflow of water to residential areas, working like levees.
- Town reconstruction plans are making the best use of this lesson learned.

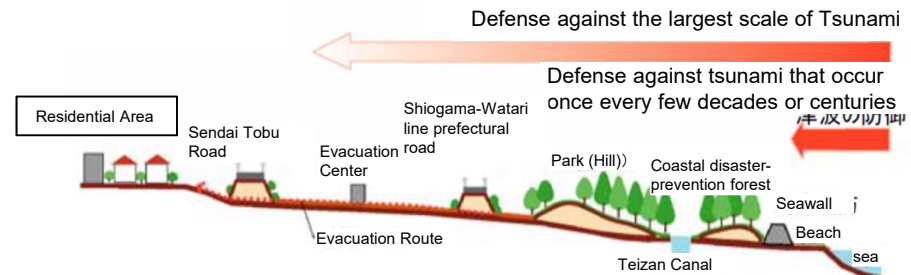
Tsunami Prevention (Cross-section view)

- Disaster reduction measures are being implemented: construction of seawalls and banking as well as raised roads with an embankment function (including the Shiogama-Watari line prefectural road), recreation of tougher tsunami-prevention forests on coastal areas

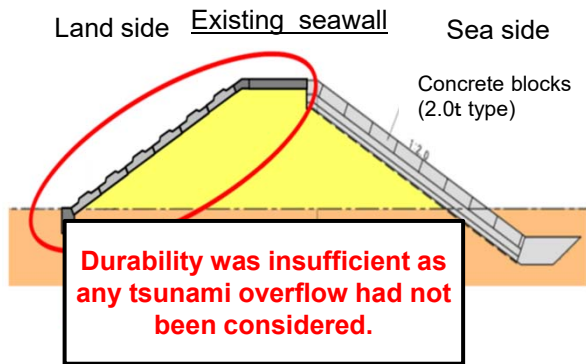
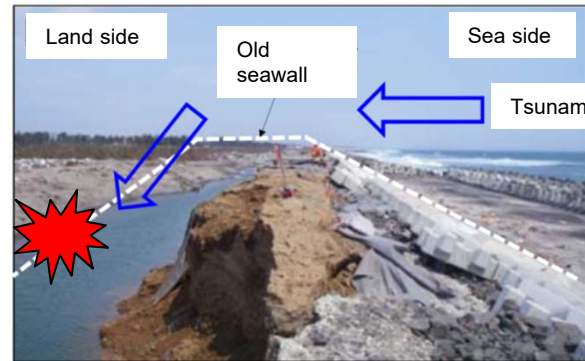
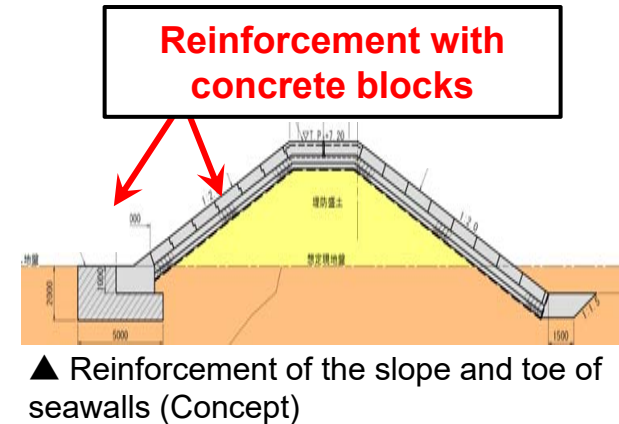
- Many facilities were damaged by the tsunami inflow over seawalls.
- To secure sufficient time to evacuate, the durability of seawalls is being improved by providing more strength to the land side slopes with concrete blocks.

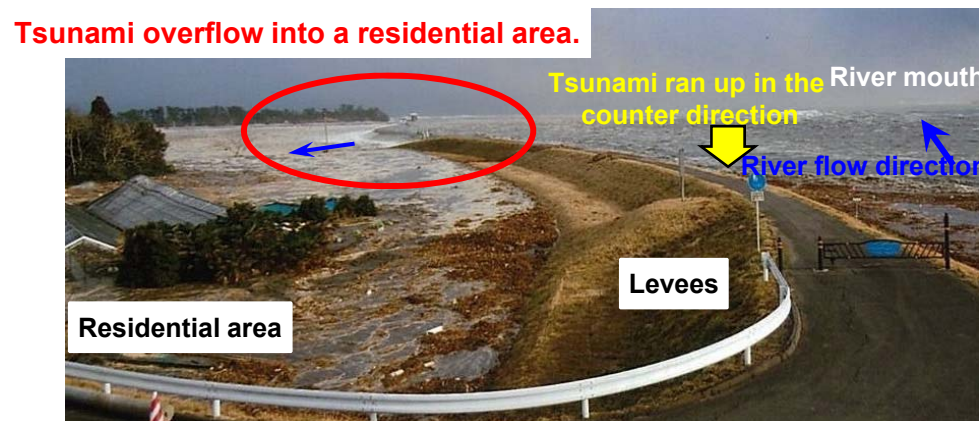
▲Tsunami overflowed into the residential area, surpassing the levee. (Abukuma Riv. left bank, Terashima District, Iwanuma City, Iwate Pref.)

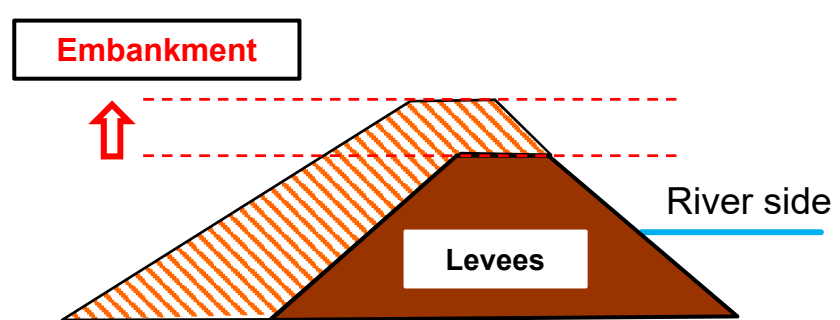
- Many residential areas were devastated by the tsunami that ran up rivers and overflowed levees.
- Additional embankment works are being added to levees with insufficient height for tsunami protection.

▲Embankment of levees (Concept)

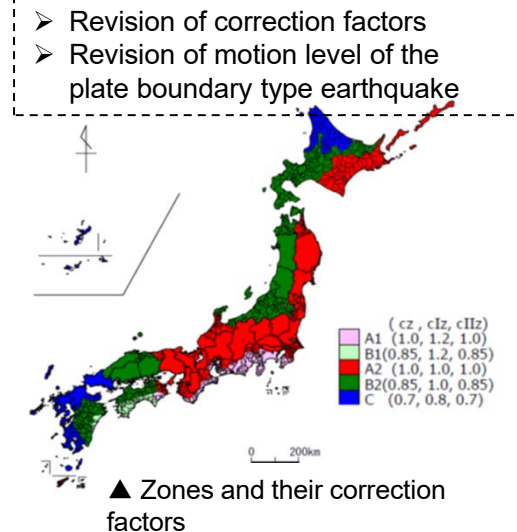
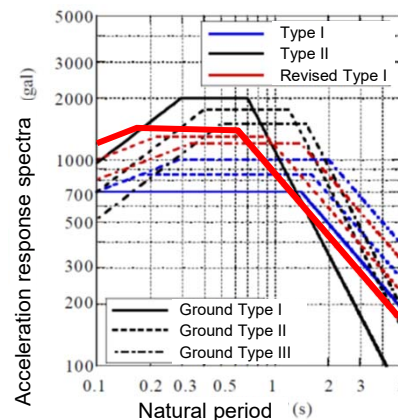
▲ Standard acceleration response spectrum to the plate boundary type earthquake motion

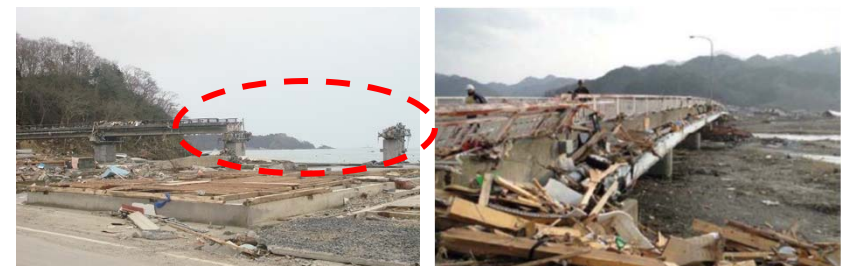
▲ This superstructure was swept away by tsunami.

▲ This bridge superstructure withstood the tsunami strikes.

- Critical points on the highway bridge design should be clearer, reflecting the lesson learned from the tsunami disaster.
- A guideline for consideration in response to massive disasters like tsunami was issued.

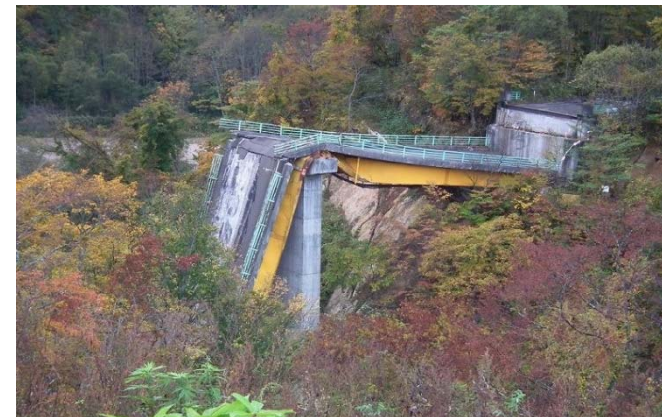
▲ Matsurube Bridge (Ichinoseki City, Iwate Pref.)
(collapsed in the Iwate Miyagi Inland Earthquake
in June, 2008)
